# **Impact Testing of Orbiter Thermal Protection System Materials**

**Presented to the 57<sup>th</sup> ARA Meeting  
Venice, Italy  
18-22 September 2006**

**Justin Kerr  
NASA Johnson Space Center  
[justin.h.kerr@nasa.gov](mailto:justin.h.kerr@nasa.gov)**

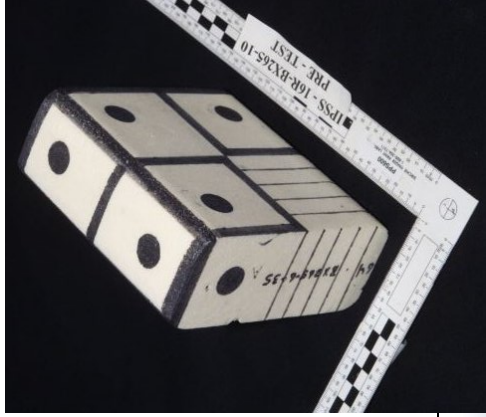
ET Foam (1/10<sup>th</sup> the size of  
that tested during the Investigation

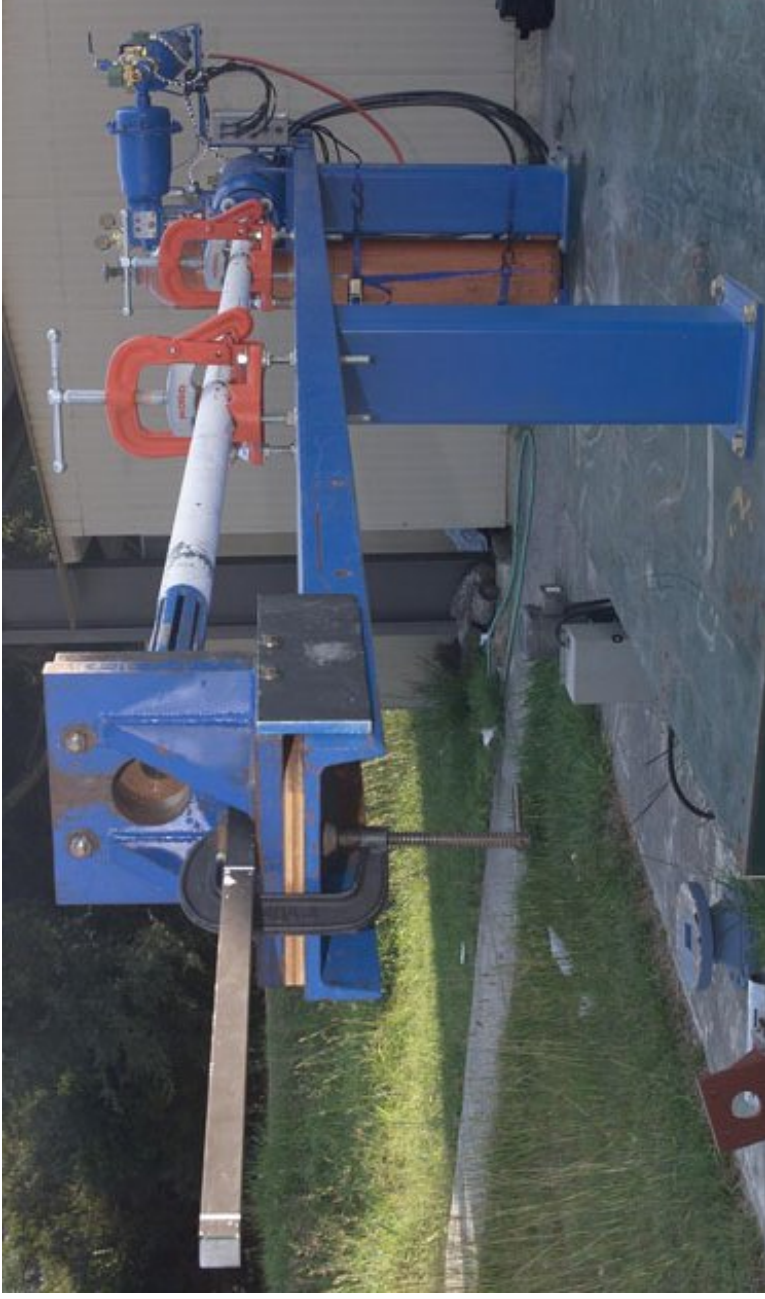
## Small Compressed Gas Gun (3 Gallon Tank)

Used to launch Ice (Low and Regular Density) and ablator    300 – 800 fps  
 $\frac{1}{2}$ " x 1" Rectangular, 2" Diameter, and 2" x 2" Square    11-foot Barrels

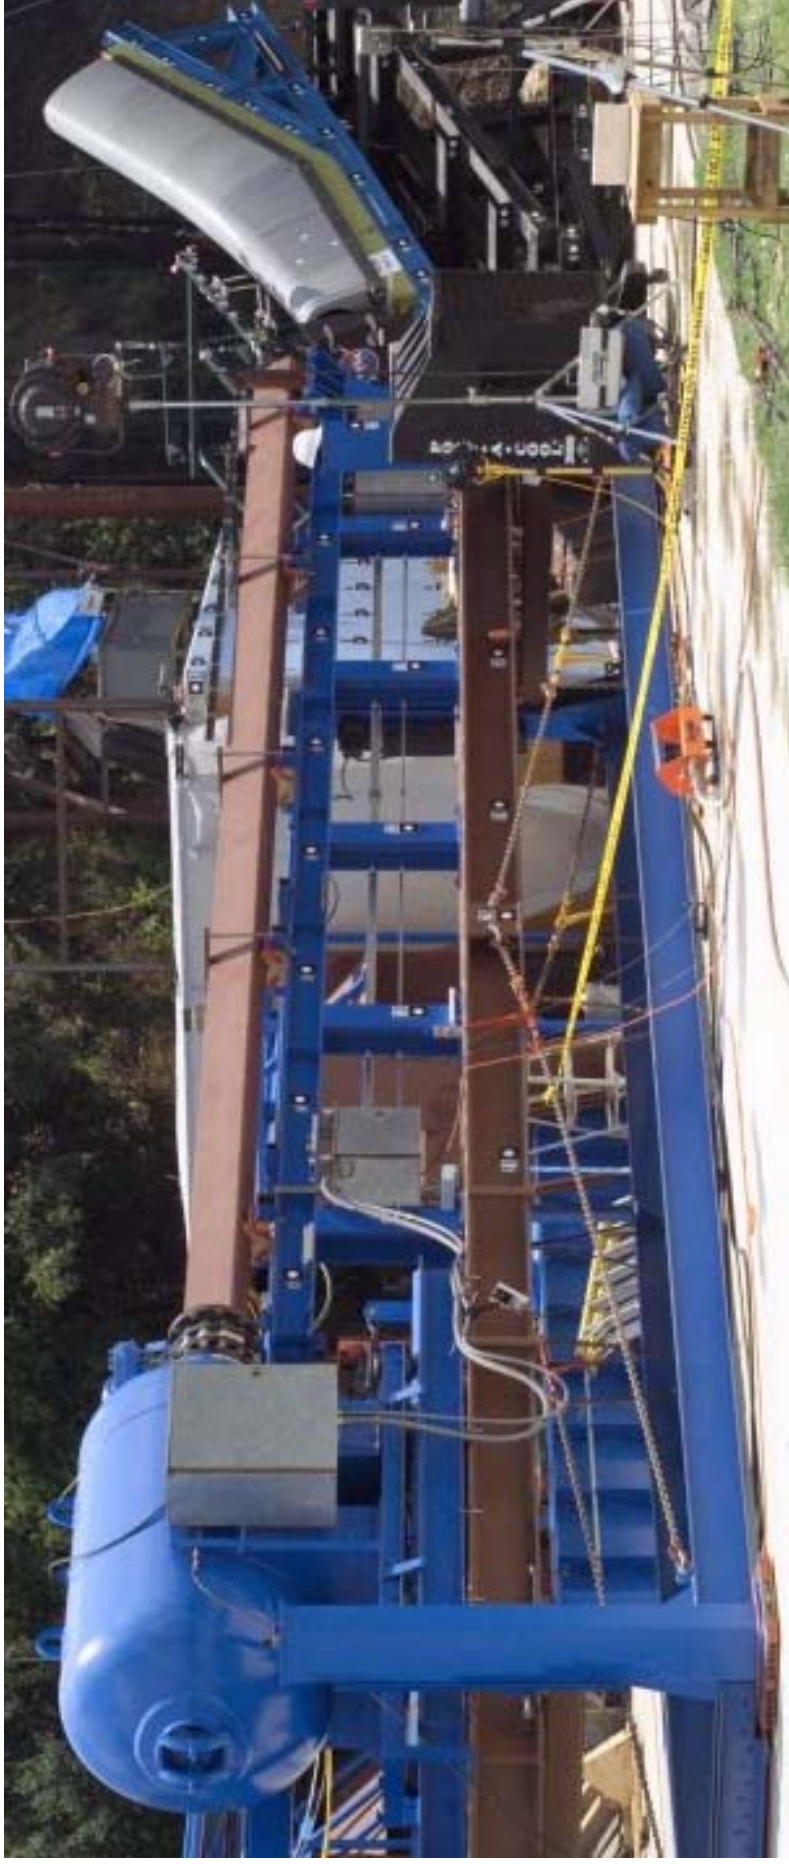
## Large Compressed Gas Gun (500 Gallon Tank)

Used to launch ET Foam

800 – 2000 fps

35 and 40-foot Steel and Aluminum Barrels with rectangular cross sections

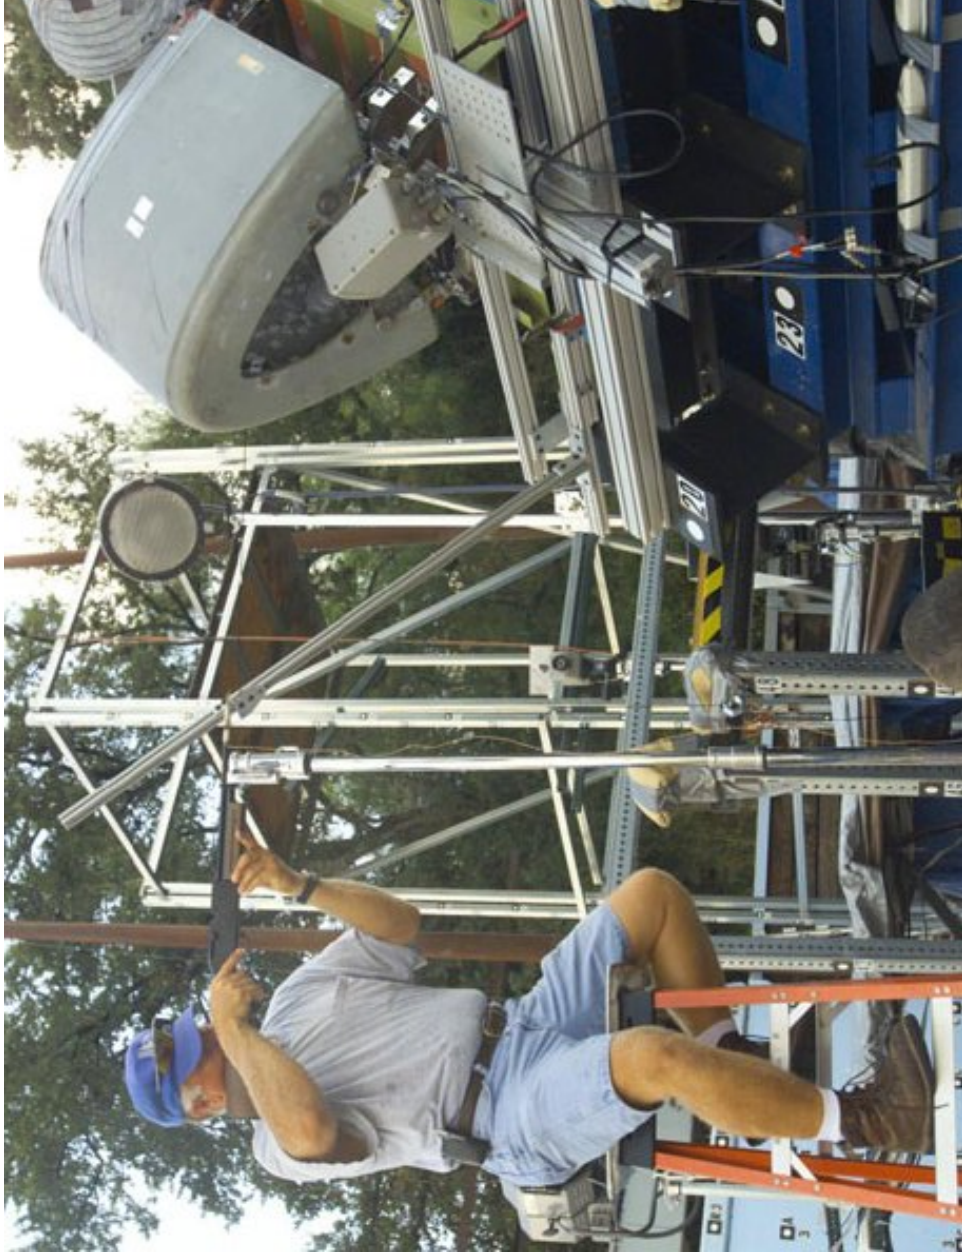
## BB Gun

Used to launch BB's at RCC Panels

0.34 grams BB's

300 – 600 fps

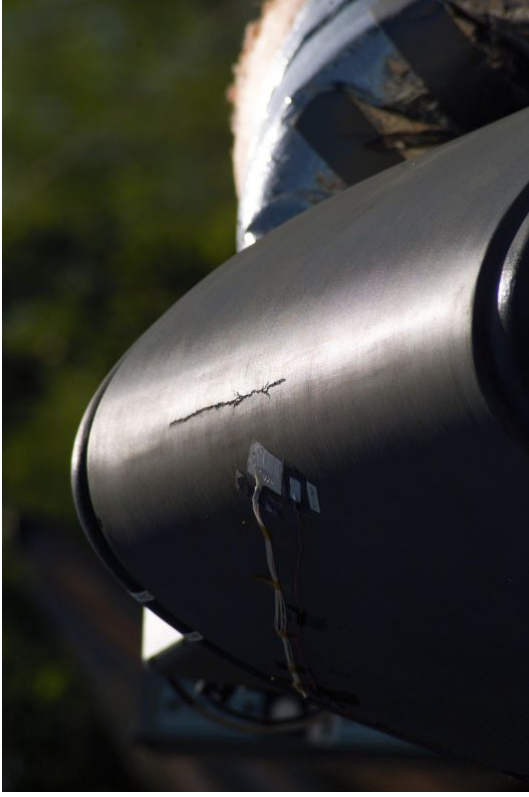
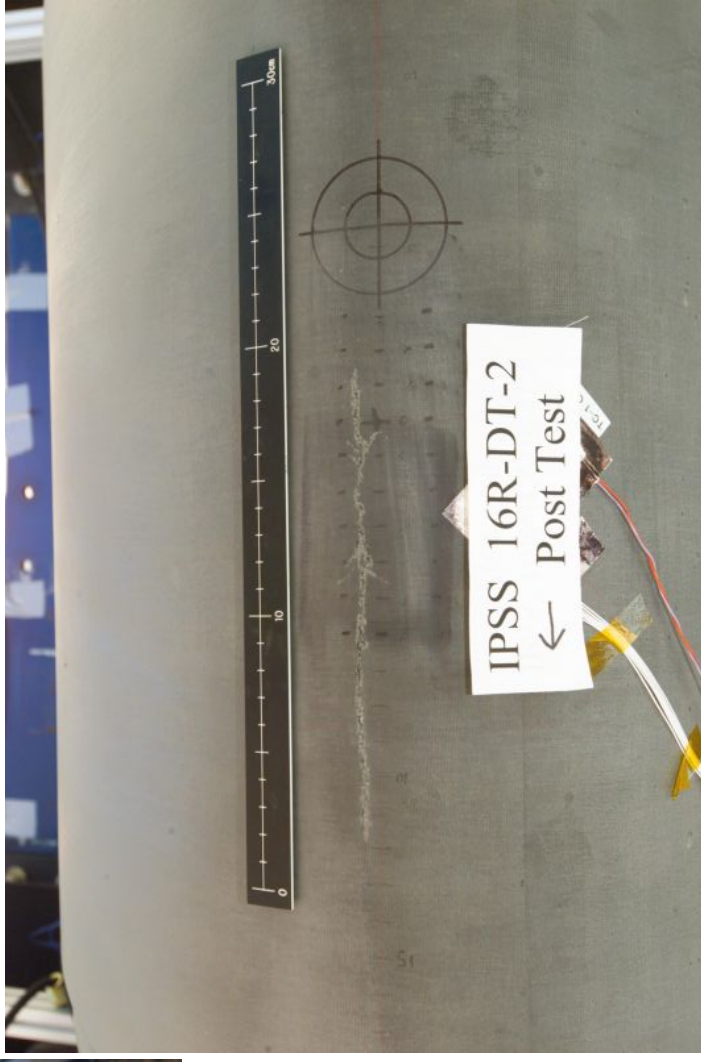
## Panel 16R impact damage

- BX-265 foam impactor
  - 2"x4"x6" (0.06 lb)
  - V=1375 ft/s
  - KE=1384 ft/s
  - Angle=45 degrees
- Through thickness crack of the panel
- Damage length is 6.99"

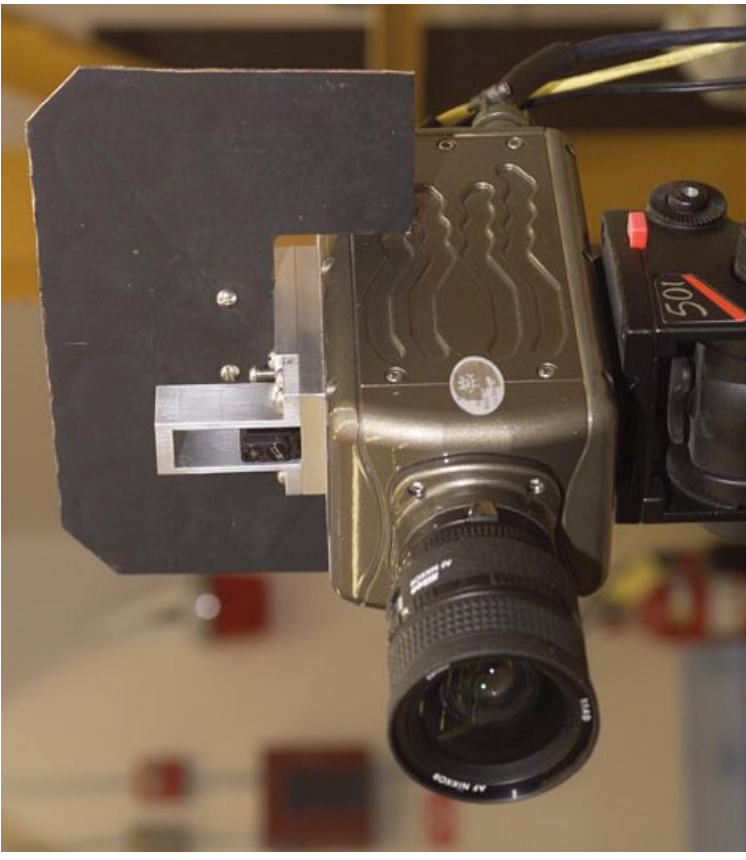
# High Speed Cameras and Lighting

- Phantom V7 cameras are used to measure the projectile velocity
- Framing rates of 5000 to 25,000
- Laser used to insure perpendicularity with the shot line
- 2 cameras are used for TPS Tile tests
- 7 cameras are used for RCC Panel tests
- 4 kW and 6 kW studio lights are used for illumination of the targets
- Up to two 6 kW and four 4 kW lights per shot (28 kW/shot)
